# Board Level Failure Analysis of Chip Scale Package Drop Test Assemblies

Nicholas Vickers, Kyle Rauen, Andrew Farris, Jianbiao Pan  
Cal Poly State University  
San Luis Obispo, CA 93407

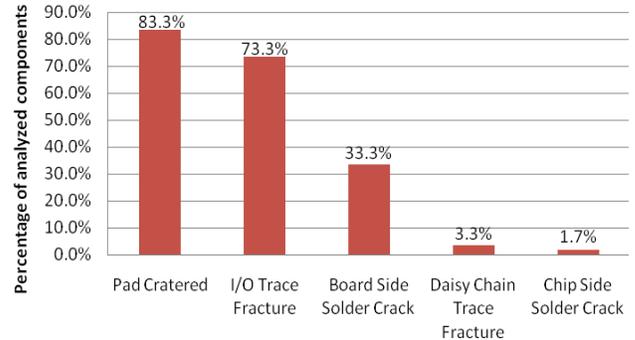
After analyzing 60 components on four boards that were dye penetrated, five failure modes have been identified: 1) pad cratering, 2) solder cracking near the board side, 3) solder cracking near the component side, 4) input/output (I/O) trace fracture, and 5) daisy chain trace fracture. Figure 2

summarizes the percentage of each failure mode on these 60 components analyzed. It shows that pad cratering is the dominant failure mode for these test vehicles in drop impact; 83.3% of the components exhibited pad cratering. Pad cratering is defined as cracking in the thin resin rich region underneath the copper pads and traces as shown in Figure 3. Note that some components had multiple failure modes so that the total percentage shown in Figure 2 is more than 100%.

Figure 2. Summary of failure modes

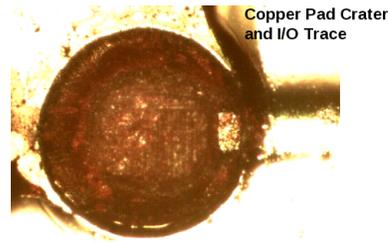
Figure 3. Copper pad cratering with dyed board fibers, 100X magnification

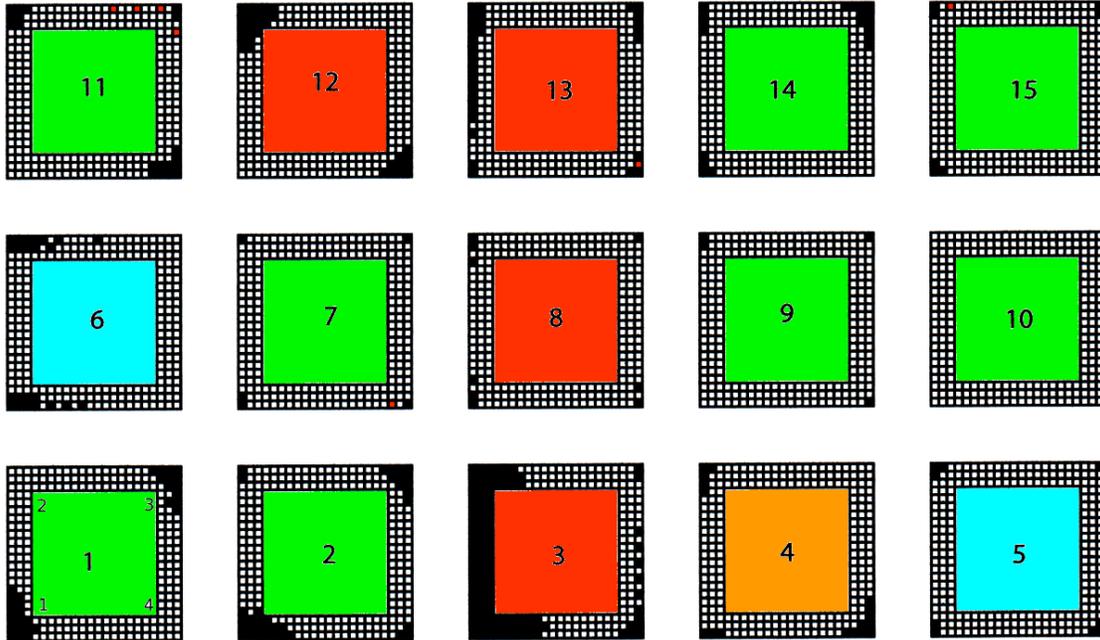
Figures 4 and 5 show boards with no edge-bonding applied to the CSPs, and Figures 6 and 7 show boards with edge-bonding applied [11]. In Figures 5 and 6, pad cratering is shown to occur on nearly every CSP after relatively few drop impacts, and may exist before without electrical failure occurs. In a few cases electrical failure occurred by trace cracking without pad cratering or solder fracture.

It is clear that pad cratering occurred mainly in the corners of the CSPs with the exceptions to components 3, 8, and 13, where it often happened along the edges. The majority of pad cratering occurred on one side of the board (toward component 6), which indicates asymmetric strain distributions along the board. A dynamic failure measurement system was used with a cable attachment near component 6.

Figure 4. Failure mode map for not edge-bonded board after 10 drops at 1500 G.

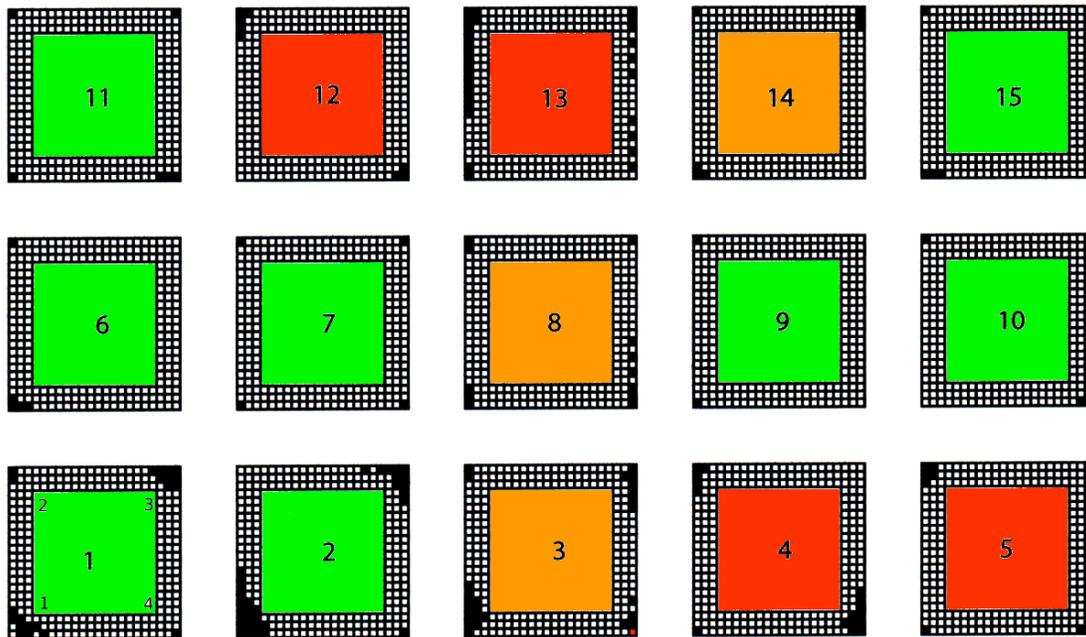
Figure 5. Failure mode map for not edge-bonded board after 14 drops at 1500 G.

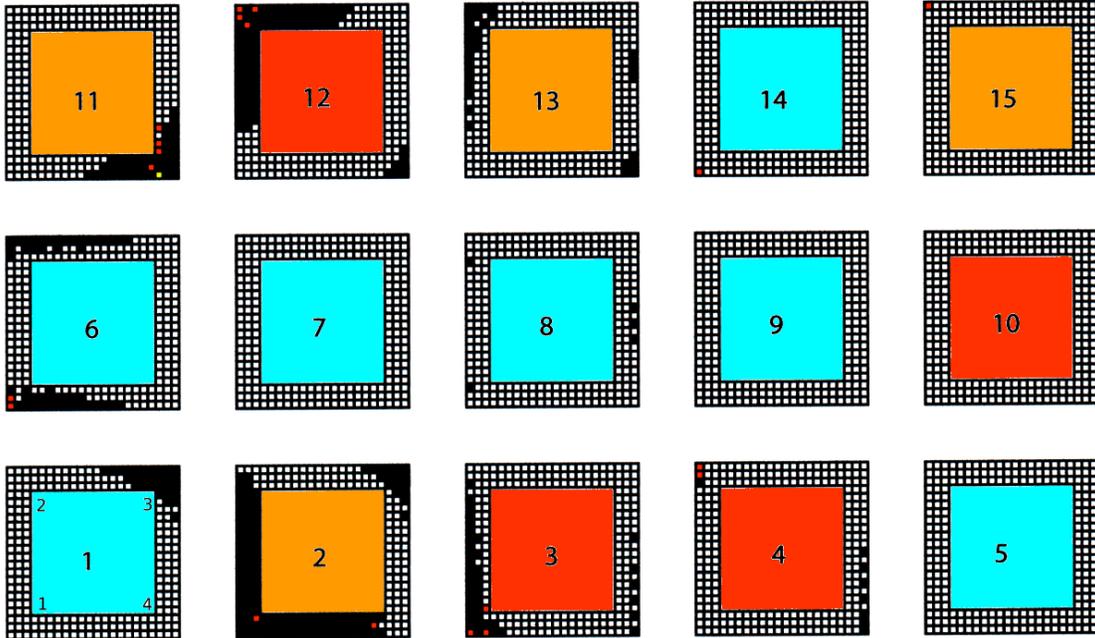
Figure 6. Failure mode map for edge-bonded board after 279 drops at 1500 G.

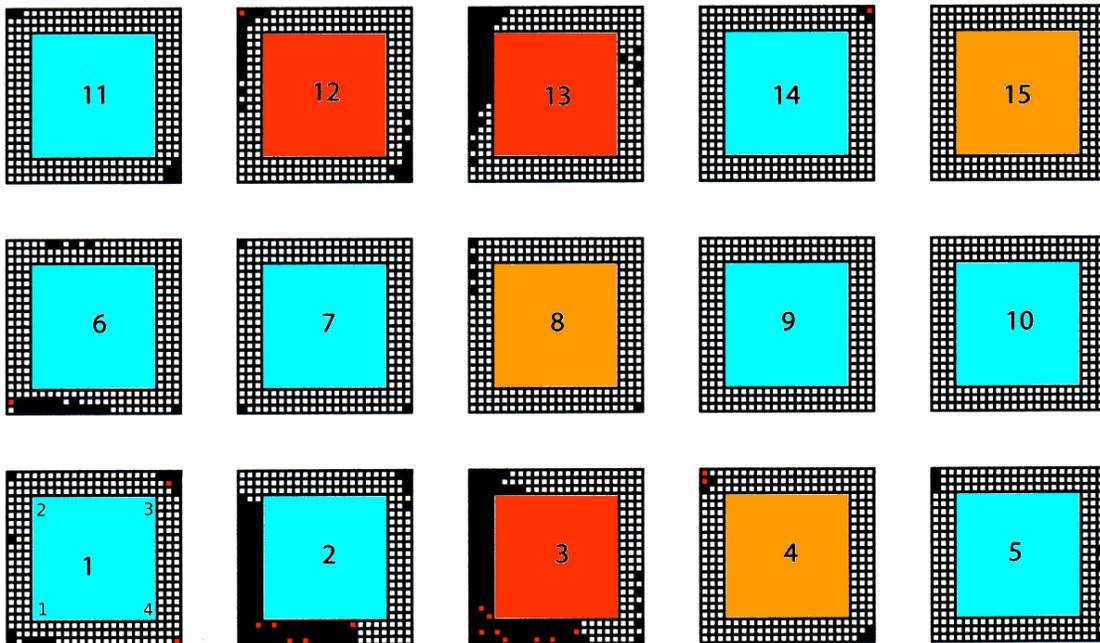
Figure 7. Failure mode map for edge-bonded board after 325 drops at 1500 G.

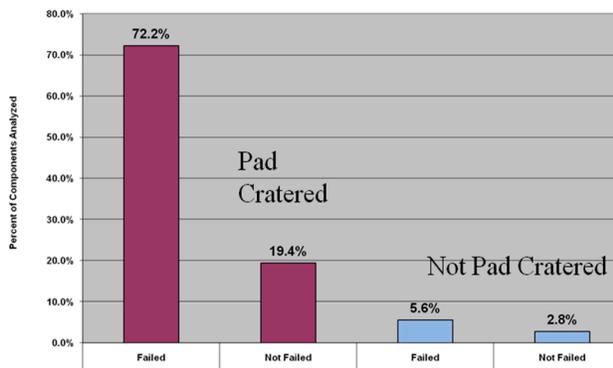
It should be pointed out that pad cratering does not necessarily lead to electrical failure of solder joints. Figure 8 shows the relationship between pad cratering and electrical failure. It shows that 19.4% of components that had pad cratering did not fail electrically. The figure also indicates that most components that electrically failed exhibit pad cratering, but pad cratering occurred on some components that were not yet failed; pad cratering

implying that daisy chain trace fracture is caused by pad cratering. Conversely, solder cracking appears to be independent of pad cratering. This is shown by Figure 8 where 5.6% of electrical failures are caused by solder cracking where pad cratering was not observed. Cracking of the solder joints on the board side and component side was observed in 33.3% and 1.3% of the components, respectively.

Figure 8. The relationship observed between pad cratering and electrical failure

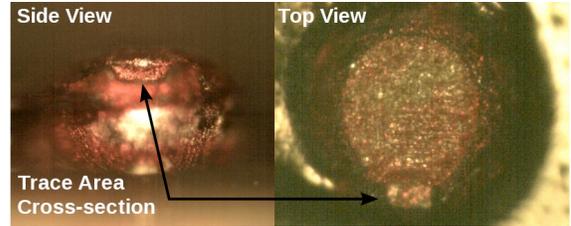
The second most common failure mode is I/O trace fracture as shown in Figure 9. All components that exhibit I/O trace failures also exhibit pad cratering. 72.2% of pad cratered components exhibit I/O trace fracture implying that the two failure modes are coupled. Similarly all daisy chain trace fractured components exhibit pad cratering,

Combining the failure analysis with the reliability study previously reported [11], we see that pad cratering indirectly causes electrical failure. The reasons for this are simple, when the resin cracks under the solder joint, stress is then shifted on to the electrical trace on the PCB. When this occurs the trace can fracture as illustrated in Figure 10. These trace fractures occur both at outside trace connections where the input and output signals occur, and also in traces that connect solder balls within the BGA.

Figure 9. I/O trace cracked away from solder joint, 100X magnification

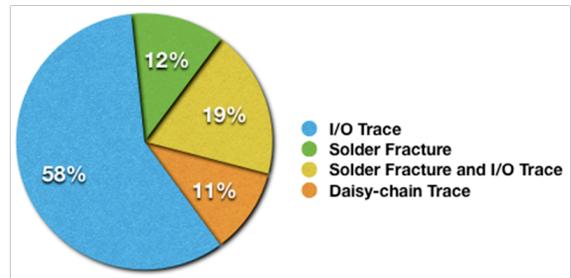
Figure 11 compares the ratios of failure modes. Input/output trace failures were attributed to causing 77% of the electrical failures. Of that 77%, 19% were in conjunction with solder fracture. Solder fracture accounts for 12% of the electrical failures observed, and 11% of the electrical failures were caused by the daisy chain trace fracturing.

Figure 11. Percentage of electrical failure attributed to the different material failure modes

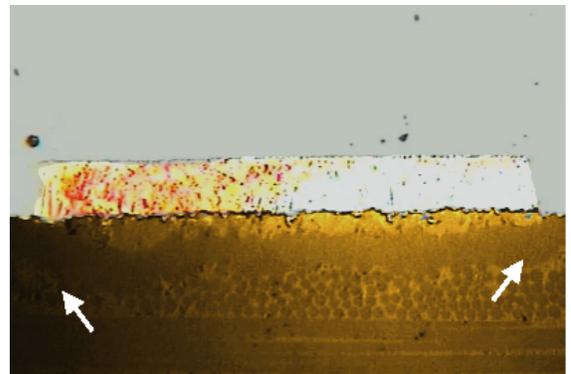
Cross sectioning SEM showed three different failure modes: 1) pad cratering, 2) daisy chain trace fracture, and 3) solder fracture on the board side. Pad cratering as shown in Figure 12 was observed near the corners of the component. Resin cracks that cause pad cratering never penetrated into the weave region and occurred only in the resin rich region above the fiber weave near copper pads and traces. Resin cracks exhibited brittle fracture characteristics. Both daisy chain trace cracking and solder cracking as shown in Figure 13 are less common.

Figure 12. Resin cracks beneath copper pad. Magnification is 500X

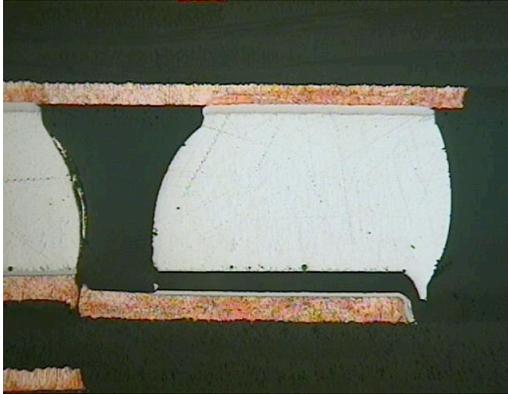
Figure 13. Solder crack near board side IMC shown on the right side of the picture. On the left is evidence of a daisy chain trace fracture on the board side at 100X magnification.

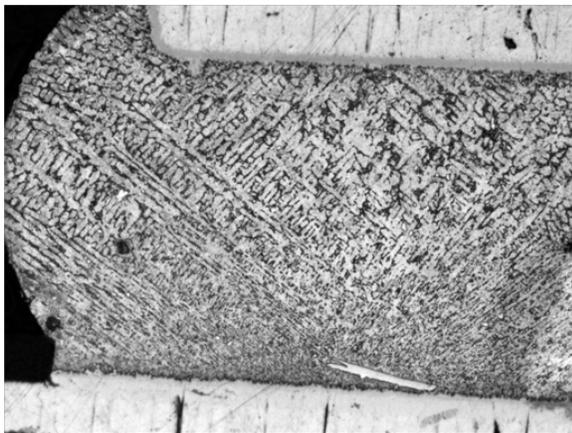
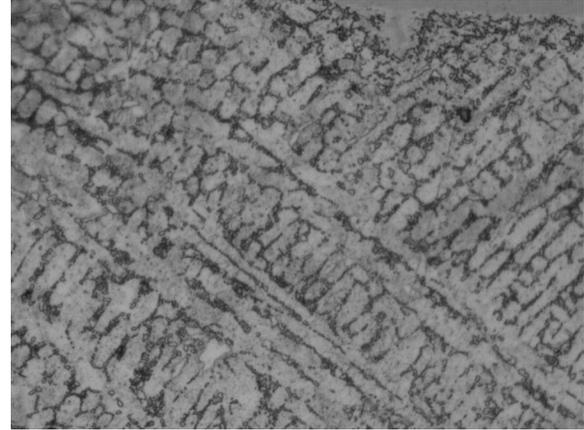
After evaluating the cross-sectioned samples, an investigation of the solder ball microstructure and also the relative strength of the solder material compared to the resin was performed. The resulting microstructure of the solder ball as shown in Figures 14a and 14b shows small dendritic grain growth. The smaller grains strengthen the solder material. Failures are consequently shifted to the weaker material, the resin. Figure 15 shows the microhardness test results. The solder material had an average microhardness of 72 while the resin has a microhardness of 33. The result indicates that the solder is much stronger than the resin. This finding verifies that the resin is the weakest link and suggests that pad cratering should be the most common material failure.

Figure 14a. Image of solder ball microstructure at 200X magnification.

Figure 14b. Image of solder ball microstructure at 500X magnification.

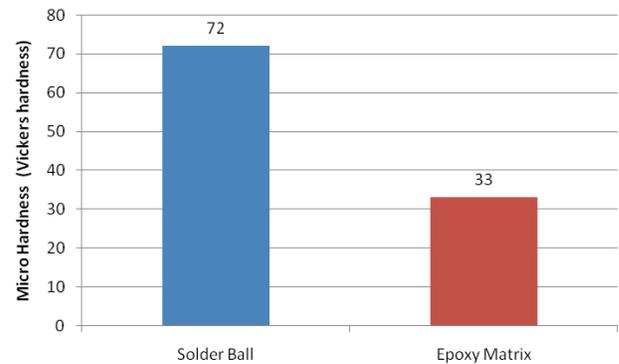
Figure 15. Results of the microhardness testing
