Drop Test Reliability of Lead-free Chip Scale Packages

This paper presents the drop test reliability of 0.5mm pitch lead-free chip scale packages (CSPs). Fifteen 0.5mm pitch CSPs were assembled on a standard JEDEC drop reliability test board with Sn3.0Ag0.5Cu lead-free solder. Eight boards were edge-bonded with a UV-cured acrylic; eight boards were edge-bonded with a thermal-cured epoxy; and twelve boards were assembled without edge bonding. Half of the edge-bonded test boards were subjected to drop tests at a peak acceleration of 1500G with a pulse duration of 0.5ms, and the other half subjected to drop tests at a peak acceleration of 2900G with a pulse duration of 0.3ms. Half of the test boards without edge bonding were subjected to drop tests at a peak acceleration of 900G with a pulse duration of 0.7ms, and the other half subjected to drop tests at a peak acceleration of 1500G with a pulse duration of 0.5ms. Two drop test failure detection systems were used in this study to monitor the failure of solder joints: a high-speed resistance measurement system and a post-drop static resistance measurement system. The high-speed resistance measurement system, which has a scan frequenc

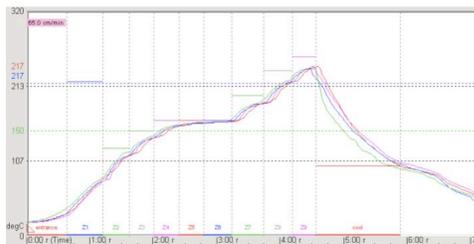
Figure 2. Solder reflow profile

Sn3.0Ag0.5Cu (SAC305) Multicore 318LF lead-free solder paste (Type 3) was stencil printed using a DEK machine through a 4 mils thick electro-polished stencil with 12 mils square apertures. Solder paste height and volume were measured by a CyberOptic machine to ensure high printing quality. The component was picked and placed by a Siemens F5 machine. A Heller EXL1800 oven with seven heating zones and one cooling zone was used for solder reflow. The reflow oven processing was done in air. The reflow profile is shown in Figure 2.

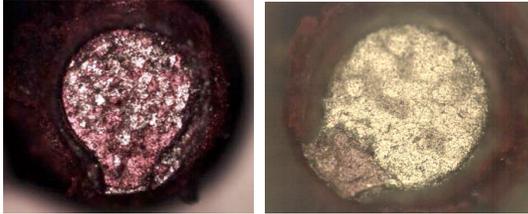
Figure 16. Complete fracture (left) and partial fracture (right)
