# Board Level Failure Analysis of Chip Scale Package Drop Test Assemblies

Nicholas Vickers, Kyle Rauen, Andrew Farris, Jianbiao Pan  
Cal Poly State University  
San Luis Obispo, CA 93407

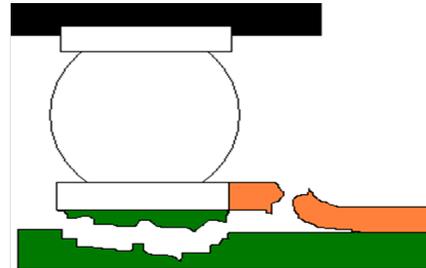
Combining the failure analysis with the reliability study previously reported [11], we see that pad cratering indirectly causes electrical failure. The reasons for this are simple, when the resin cracks under the solder joint, stress is then shifted on to the electrical trace on the PCB. When this occurs the trace can fracture as illustrated in Figure 10. These trace fractures occur both at outside trace connections where the input and output signals occur, and also in traces that connect solder balls within the BGA.

Figure 10. Illustration of cracked trace caused by pad cratering
